Richmond Refinery LPS Bulletin – Reliability

FCC Shut Down Due To Operator Interface Module Failure and CP Set-Point change

IMPACT #:12592

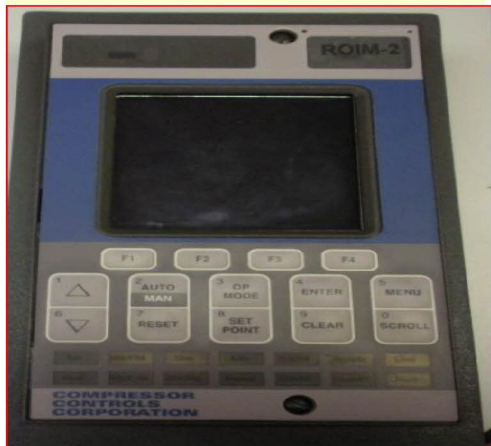
Outside OIM for operations use during daily monitoring and start up/shutdowns

The Richmond FCC experienced an emergency shutdown on 4/24/2011 due to an outside Operator Interface Module (OIM) failure. The Reactor/Regenerator d/P set point changed from 5 psi to -1 psi. This caused a sudden drop in d/P across the regenerated slide valve, which triggered a Triconex shutdown. All Emergency systems functioned properly. The plant was started back up 36 hours after the trip. A 5-Why investigation was completed.

1. The OIM in use was sent to the manufacturer (CCC) for testing. It was found to have a faulty set point controller on the face plate.
2. The OIM's are of an "aged" design and the entire system needs to be upgraded. There are limited spare parts.
3. The backup power supplied to the OIM's are called "black boxes" and it had also failed causing there to be no signal sent to the control house.
4. There is only 1 face plate for 9 OIM's in the Cracking ABU and new modules are not available.
5. The outside control systems did not have a PM or alarm test system set up to catch the failure of the black box. The signal to the house also failed.

1. Upgrade CCC controls and hardware as soon as practical or at the next major turnaround.
2. Upgrade the OIM controls to use a PC with one control point and a view option rather than using multiple controllers in the field.
3. Keep all OIMs in "FTOS" (Fault Tolerant Operating System) mode (i.e., a blank screen rather than controller selected), which will minimize the risk of a similar failure causing a set-point change.
4. Upgrade power supplies or replace with newer equipment plus have a PM/testing program in place for backup power supplies.
